JOINT U.S.-CANADA POWER SYSTEM OUTAGE TASK FORCE

UTILITY VEGETATION MANAGEMENT INITIAL REPORT

December 2003

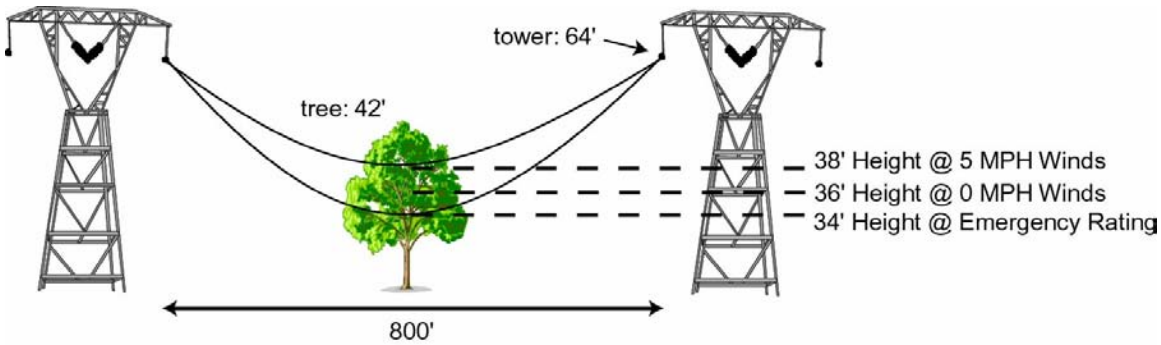
The following graphic provides an example of how conductor height can vary depending on load and wind velocity.
